Analyses of Diamond Disc Substrate Wear and Diamond Micro-Wear in Copper Chemical Mechanical Planarization Process

**Y. Zhuang ^{1,2}, A. Meled ¹, X. Wei ¹, J. Cheng ¹, Y. Sampurno ¹,
L. Borucki ², A. Philipossian ^{1,2}, M. Moinpour ³, D. Hooper ³**

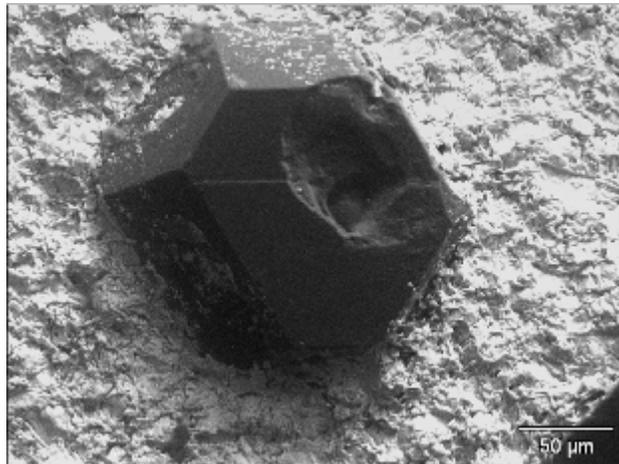
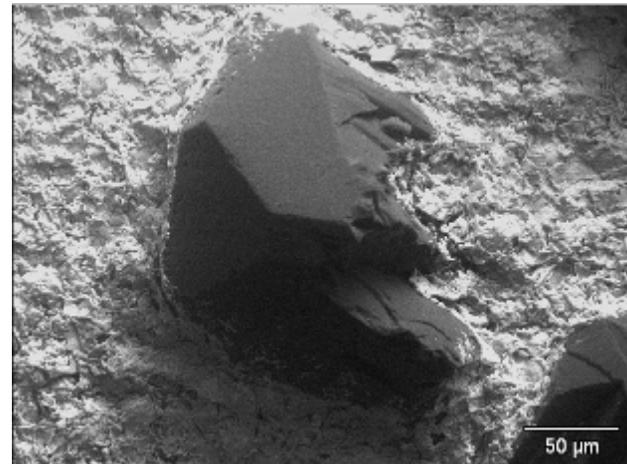
D1 with CMC iCue 600Y75 Slurry at 25 °C

There was no appreciable wear on the diamond disc substrate and diamonds.

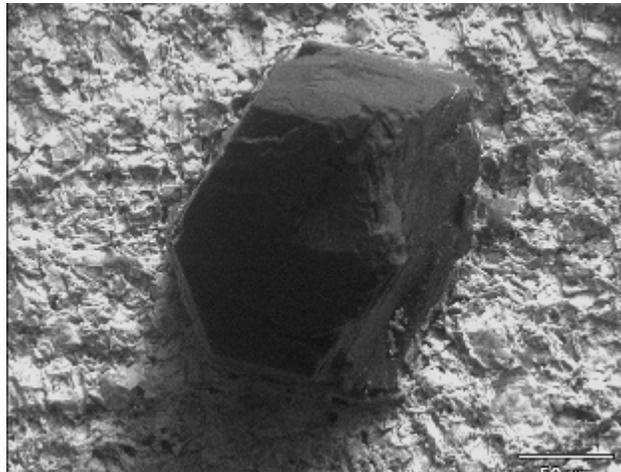
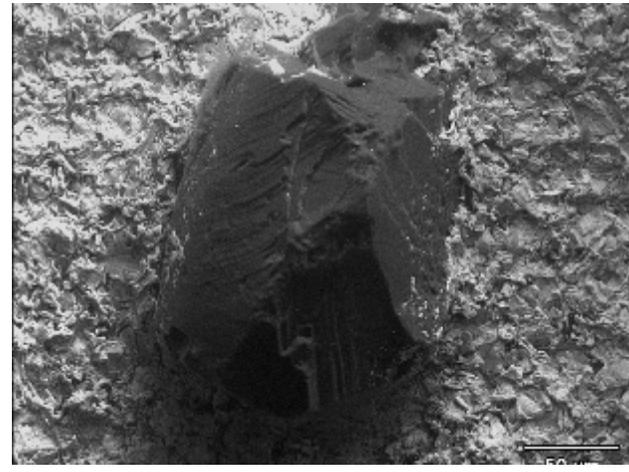
D1 with CMC iCue 600Y75 Slurry at 50 °C

There was no appreciable wear on the diamond disc substrate and diamonds.

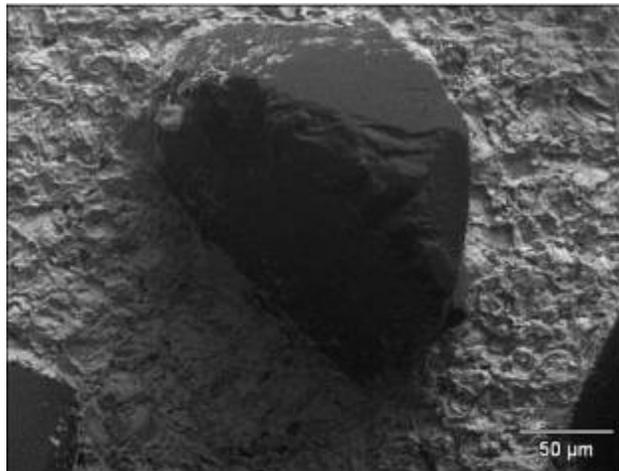
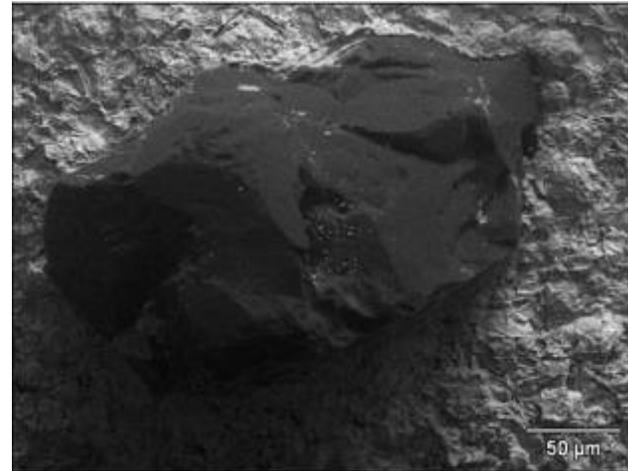
D1 with Fujimi PL-7103 Slurry at 25 °C

There was no appreciable wear on the diamond disc substrate and diamonds.

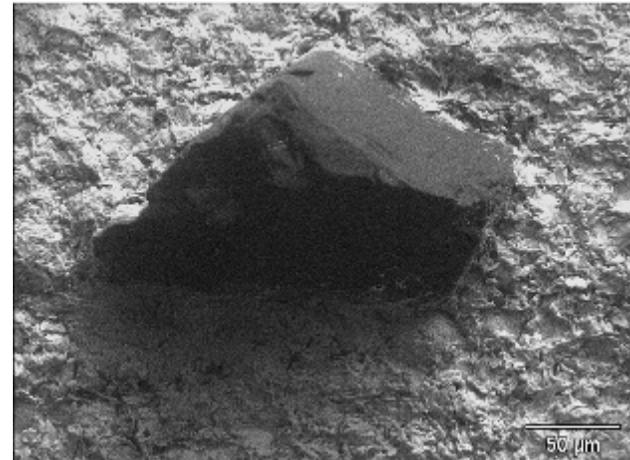
D1 with Fujimi PL-7103 Slurry at 50 °C

There was no appreciable wear on the diamond disc substrate and diamonds.

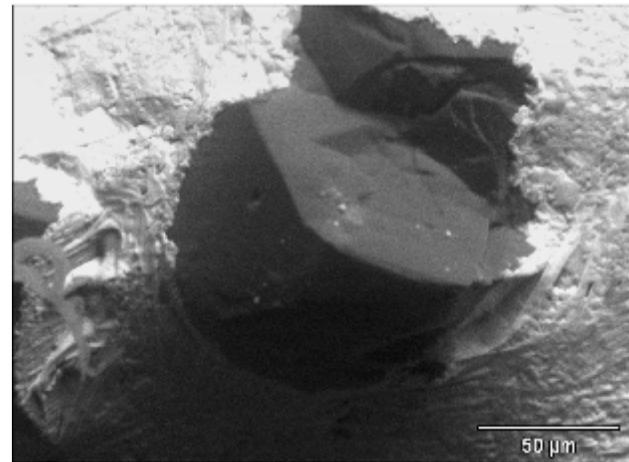
D2 with CMC iCue 600Y75 Slurry at 25 °C

There was no appreciable wear on the diamond disc substrate and diamonds.

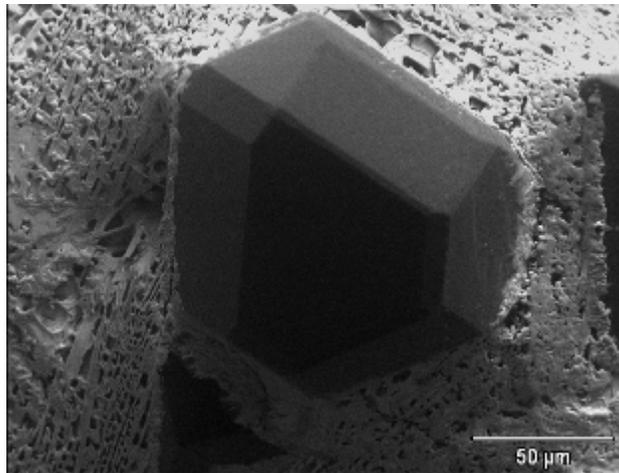
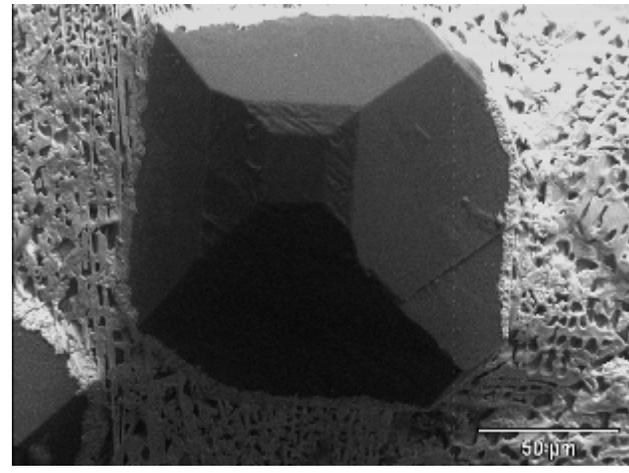
D2 with CMC iCue 600Y75 Slurry at 50 °C

There was apparent surface corrosion on the diamond disc substrate.

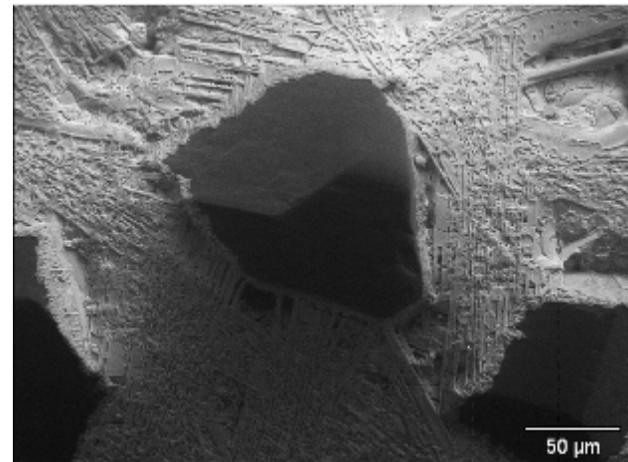
D2 with Fijimi PL-7103 Slurry at 25 °C

There was apparent surface corrosion on the diamond disc substrate.

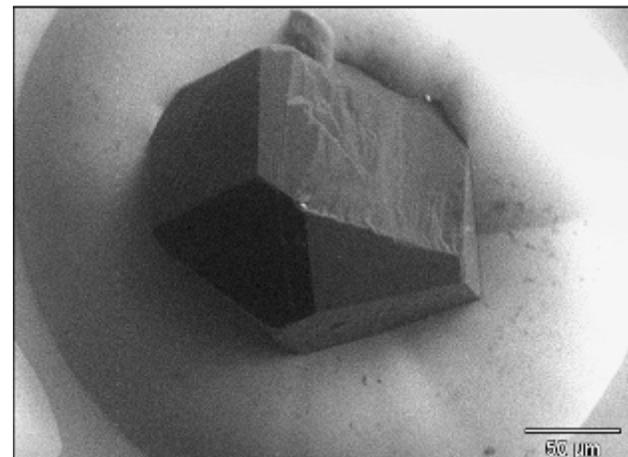
D3 with CMC iCue 600Y75 Slurry at 25 °C

There was no appreciable wear on the diamond disc substrate and diamonds.

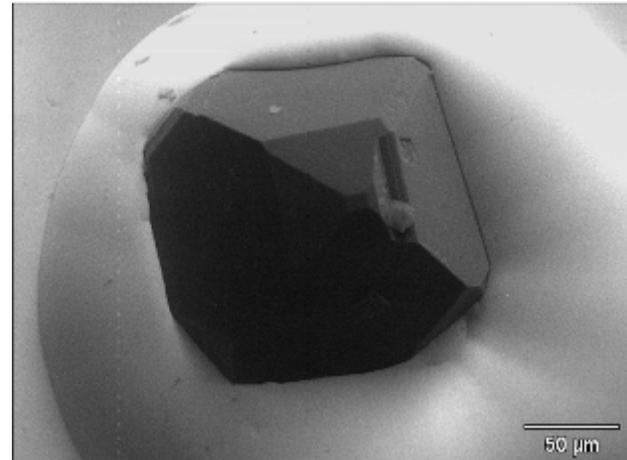
D3 with CMC iCue 600Y75 Slurry at 50 °C

There was no appreciable wear on the diamond disc substrate and diamonds.

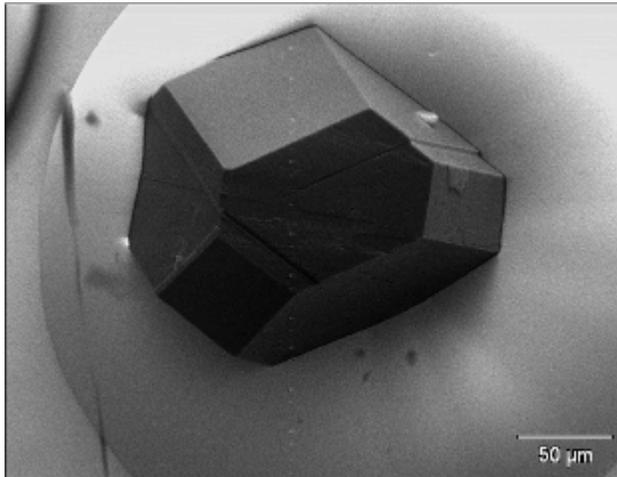
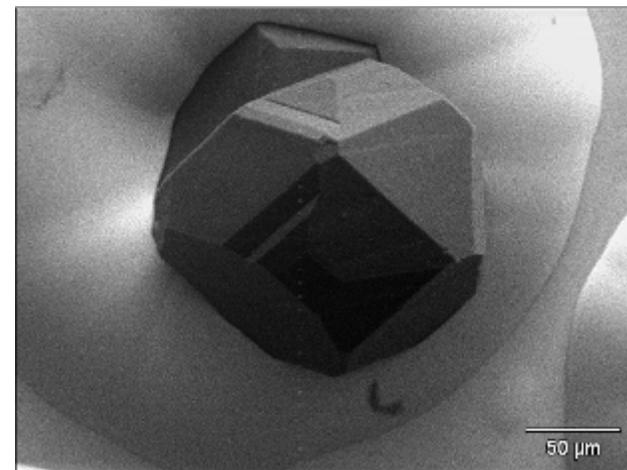
D3 with Fujimi PL-7103 Slurry at 25 °C

There was no appreciable wear on the diamond disc substrate and diamonds.

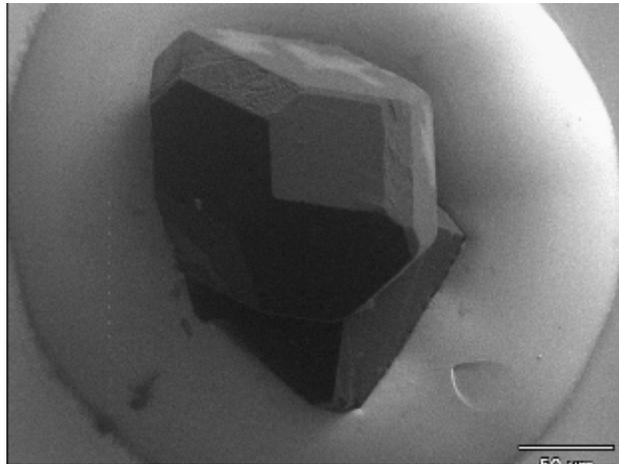
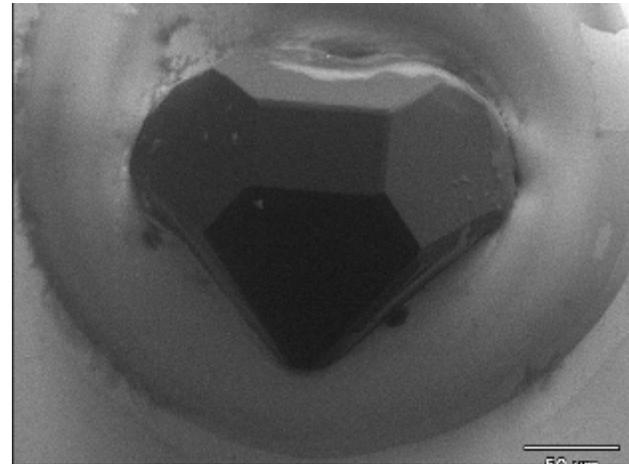
D3 with Fujimi PL-7103 Slurry at 50 °C

There was no appreciable wear on the diamond disc substrate and diamonds.

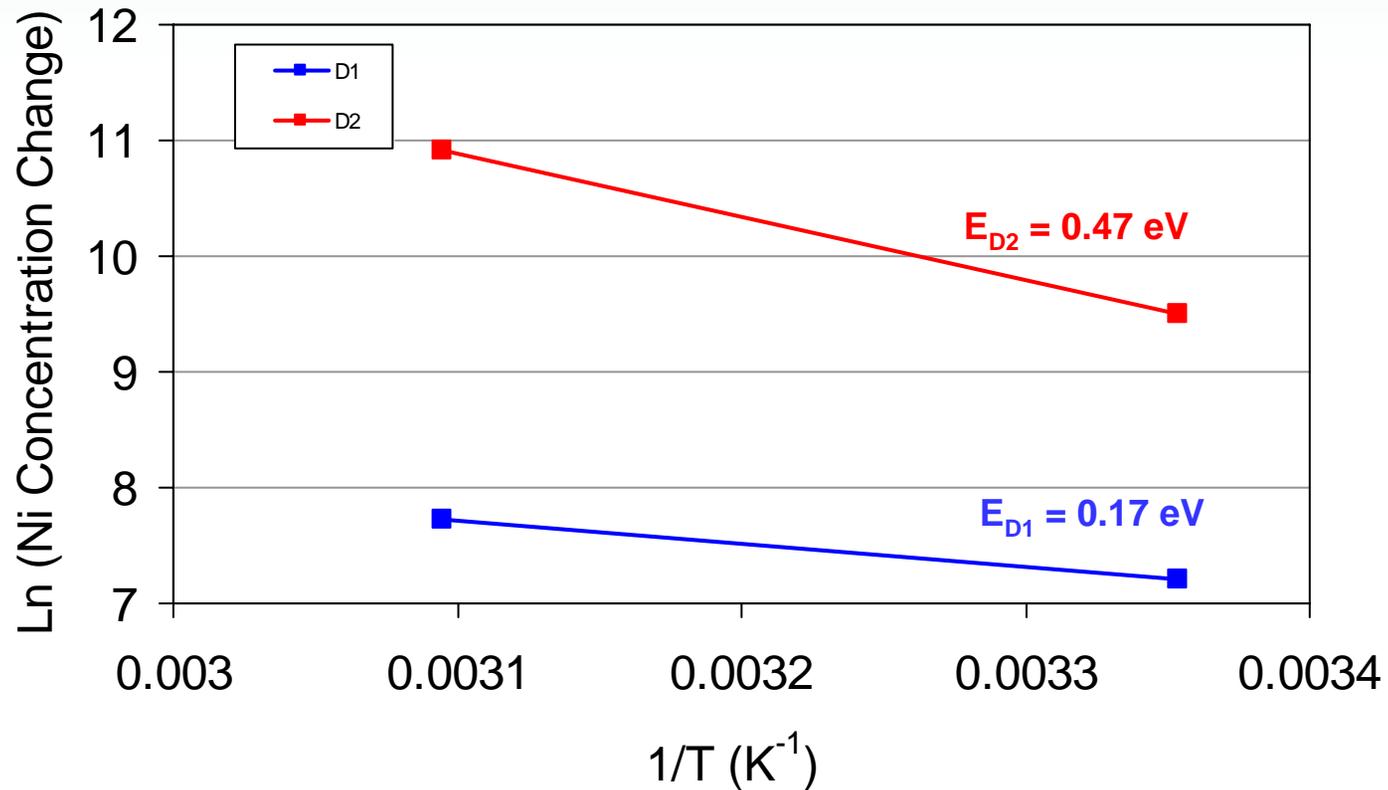
Fujimi PL-7103 Slurry

Activation Energy of Ni Corrosion

With Fujimi PL-7103 slurry, ICPMS analysis indicated that the Ni concentration in the slurry increased appreciably at 25 and 50 °C for Disc D1; the Ni concentration in the slurry increased significantly at 25 °C and increased dramatically at 50 °C for Disc D2.

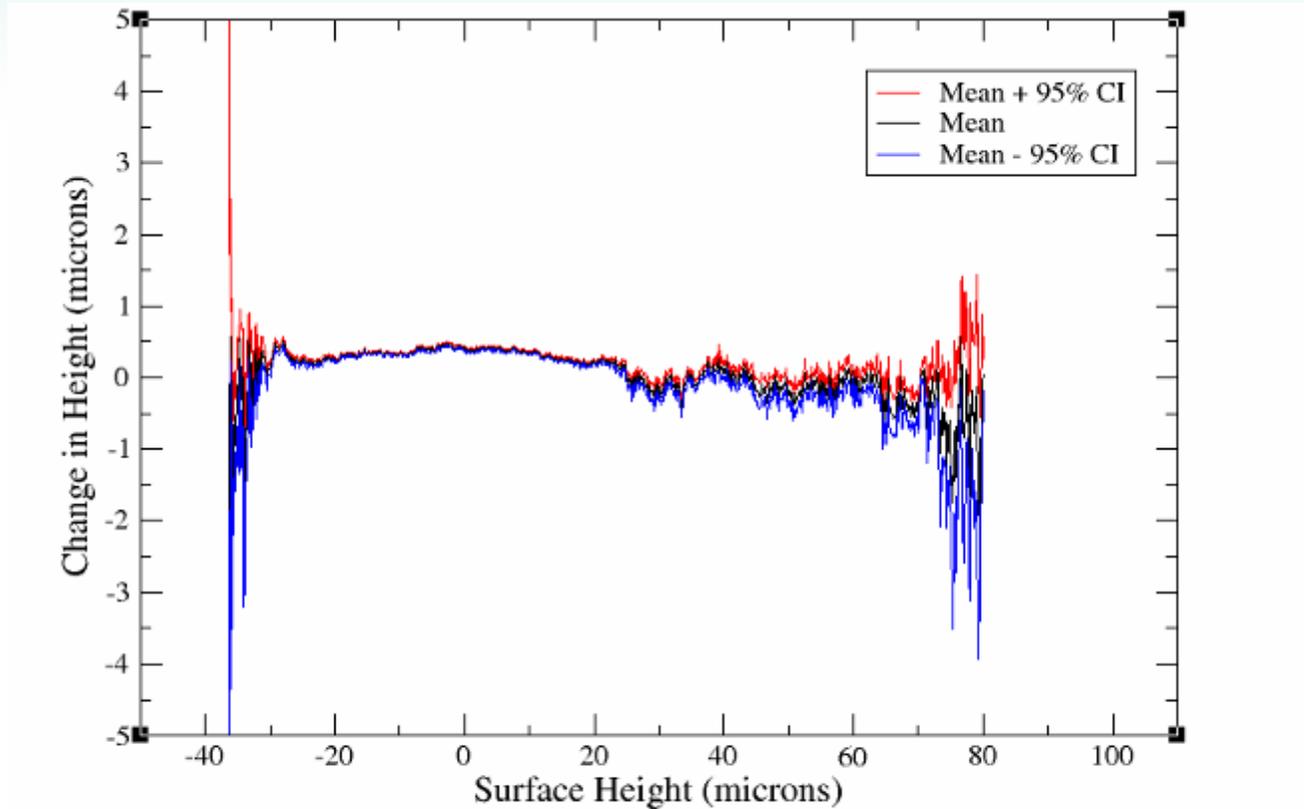
Change in Diamond Disc Surface Height

The interferometric analysis did not quantify diamond disc substrate wear accurately.

White light interferometer did not provide as detailed and accurate diamond disc images as SEM. As a result, the interferometric analysis did not quantify diamond disc substrate wear accurately.

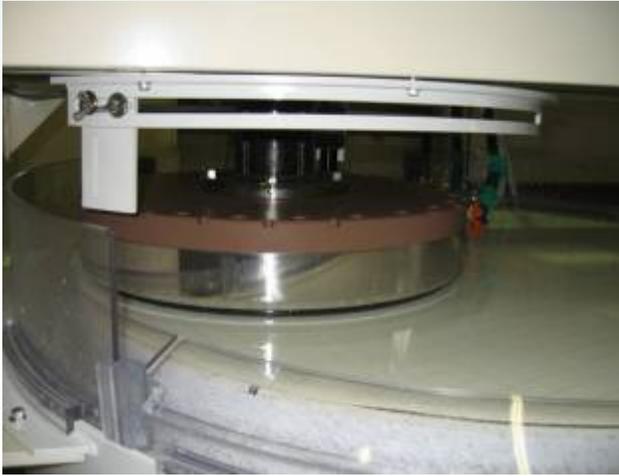
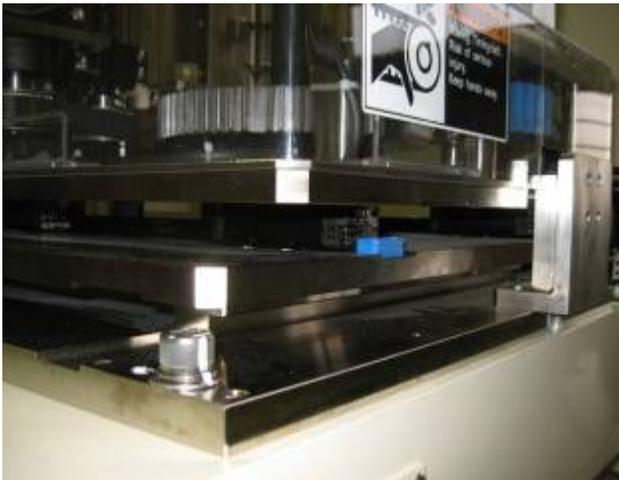
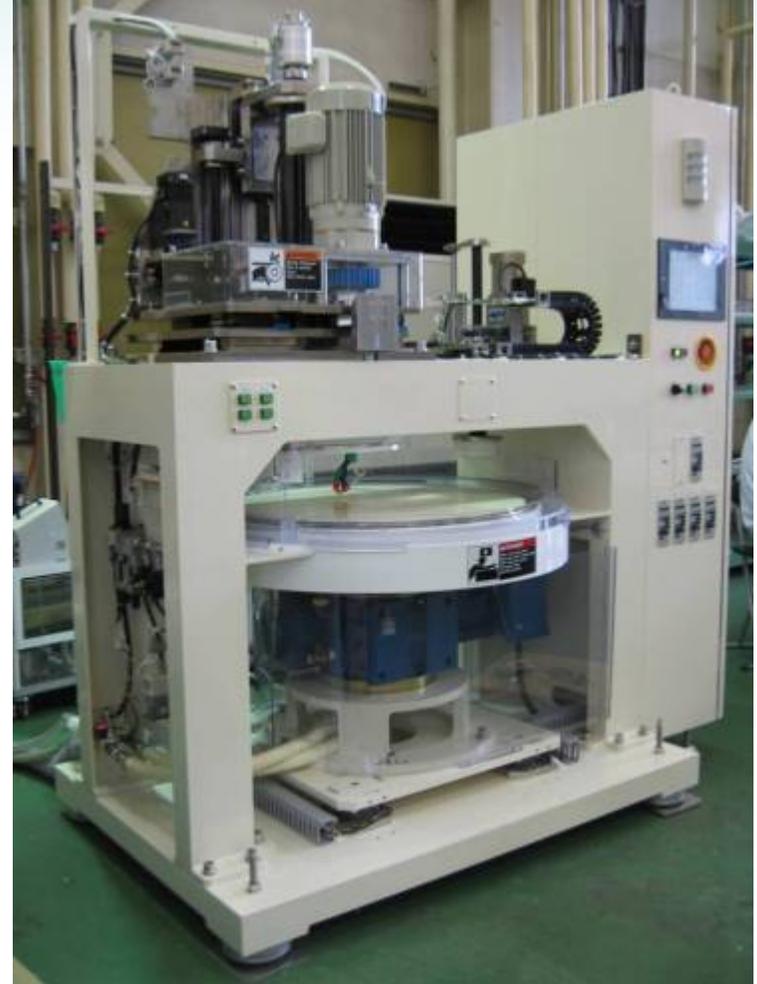
Araca APD – 800 Polisher & Tribometer

- Diamond disc rotational rate = 95 RPM
- Diamond disc sweeping rate = 10 times/min
- Platen rotational rate = 42 RPM
- Platen temperature = 25 °C
- Conditioning down force = 10 lb_f
- Conditioning time = 24 hours

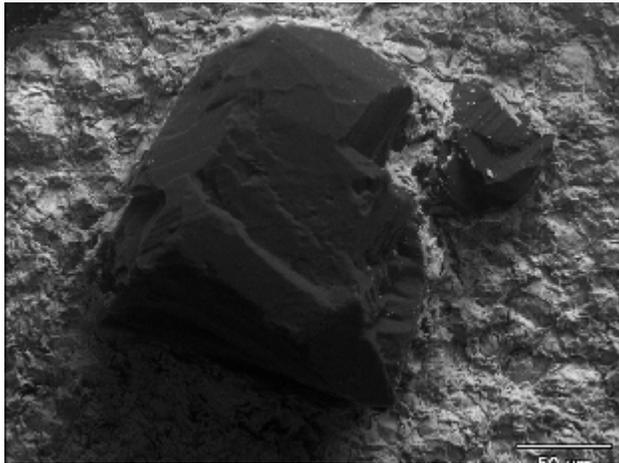
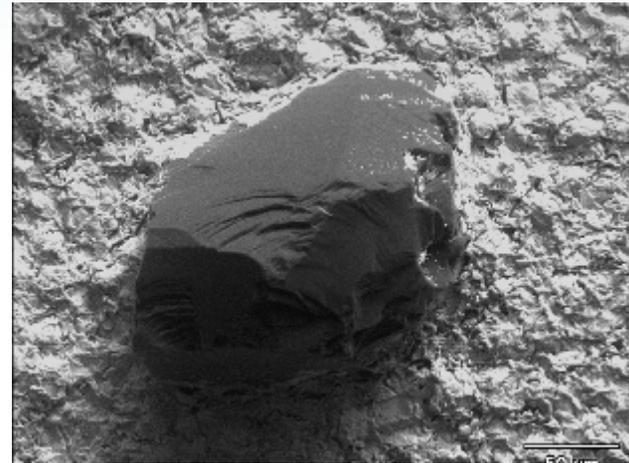
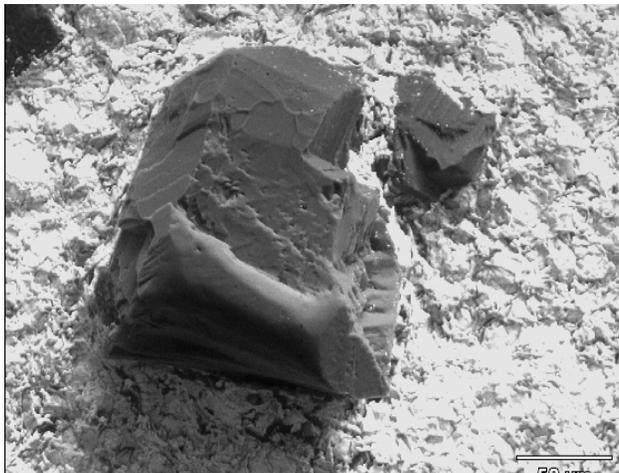
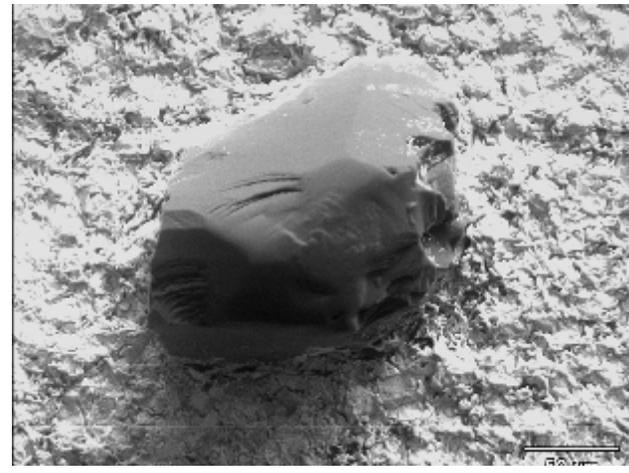
D1 with CMC iCue 600Y75 Slurry at 25 °C

**There was micro wear on the cutting edges of aggressive diamonds.
There was no appreciable wear on the diamond disc substrate.**

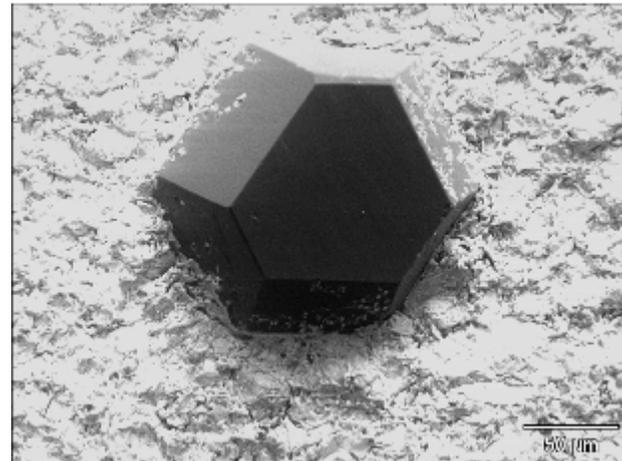
SEM Analysis – Inactive Diamond D1 with CMC iCue 600Y75 Slurry at 25 °C

There was no appreciable wear on the inactive diamond and diamond disc substrate.

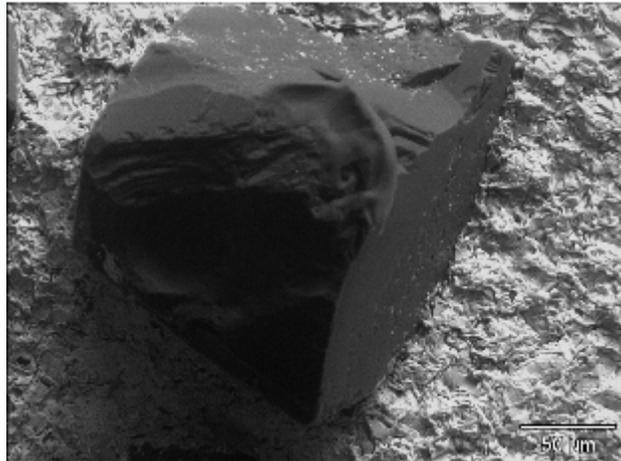
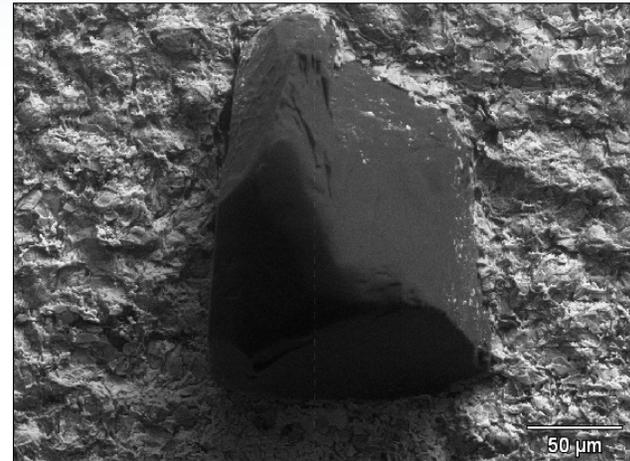
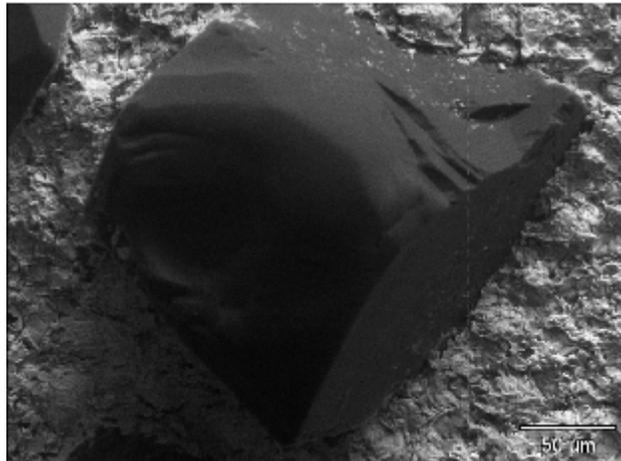
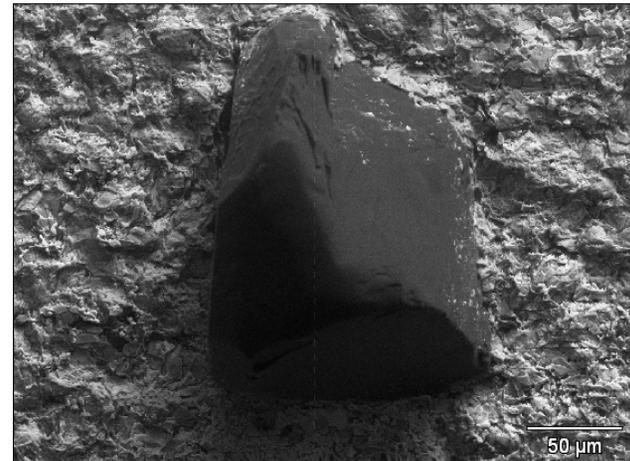
D1 with CMC iCue 600Y75 Slurry at 50 °C

**There was micro wear on the cutting edges of aggressive diamonds.
There was no appreciable wear on the diamond disc substrate.**

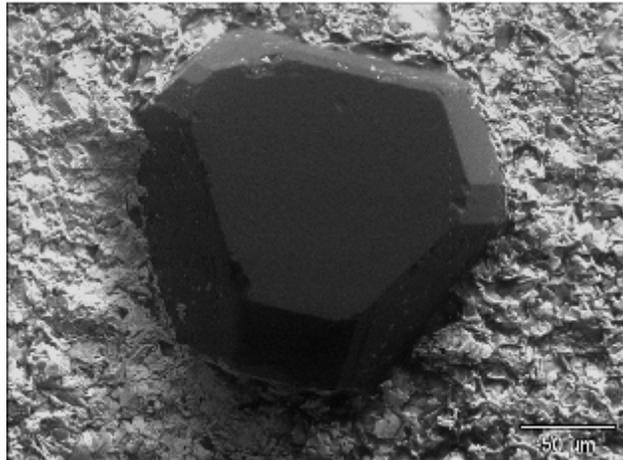
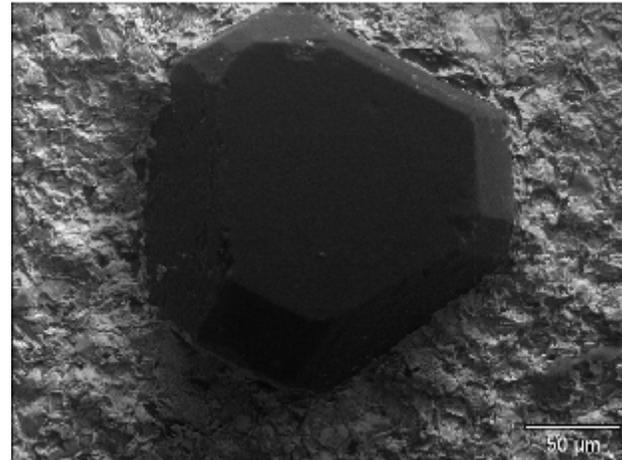
D1 with CMC iCue 600Y75 Slurry at 50 °C

There was no appreciable wear on the inactive diamond and diamond disc substrate.

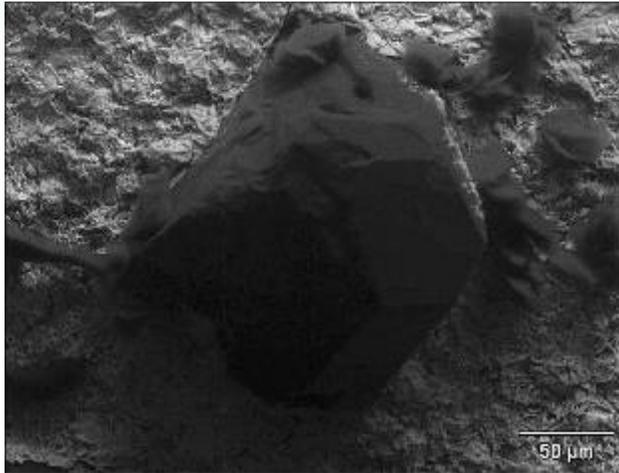
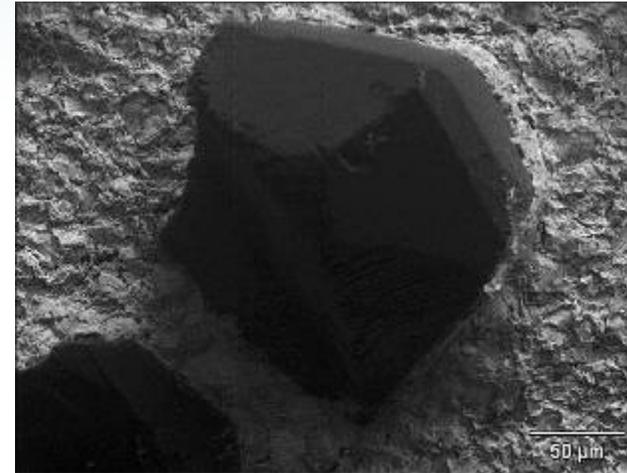
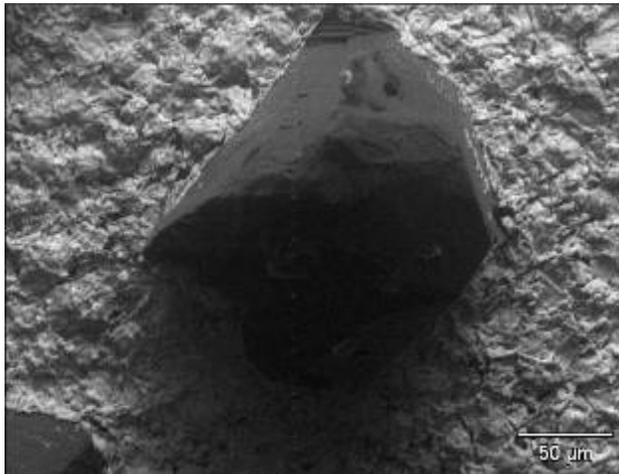
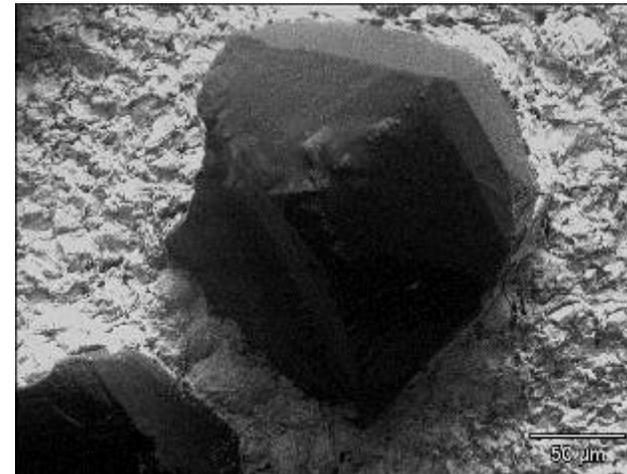
D1 with Fujimi PL-7103 Slurry at 25 °C

**There was micro wear on the cutting edges of aggressive diamonds.
There was no appreciable wear on the diamond disc substrate.**

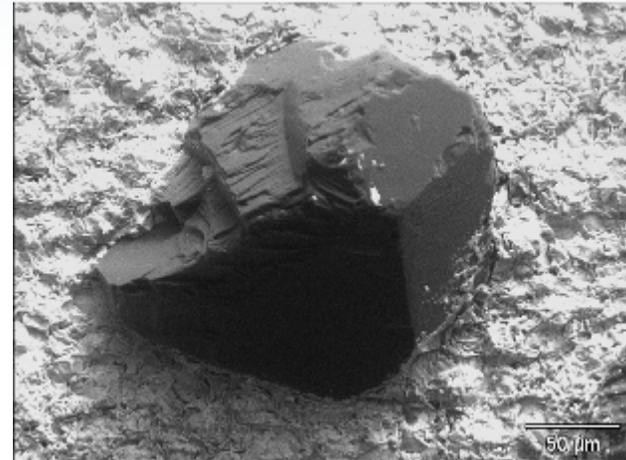
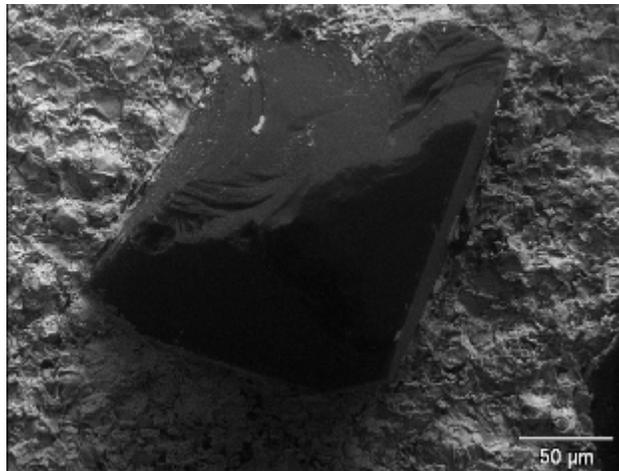
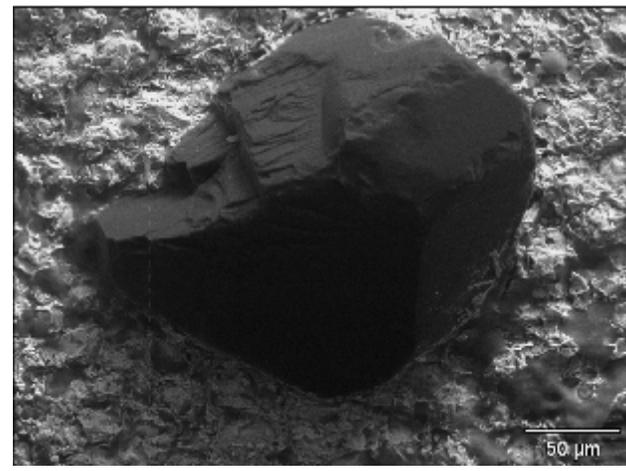
D1 with Fujimi PL-7103 Slurry at 50 °C

**There was micro wear on the cutting edges of aggressive diamonds.
There was no appreciable wear on the diamond disc substrate.**

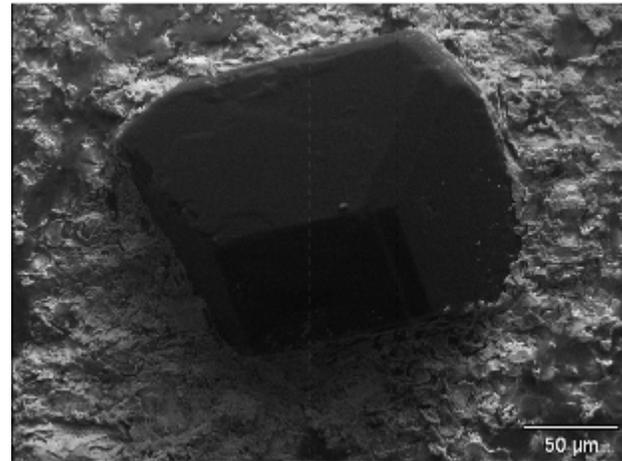
SEM Analysis – Inactive Diamond D1 with Fujimi PL-7103 Slurry at 50 °C

There was no appreciable wear on the inactive diamond and diamond disc substrate.

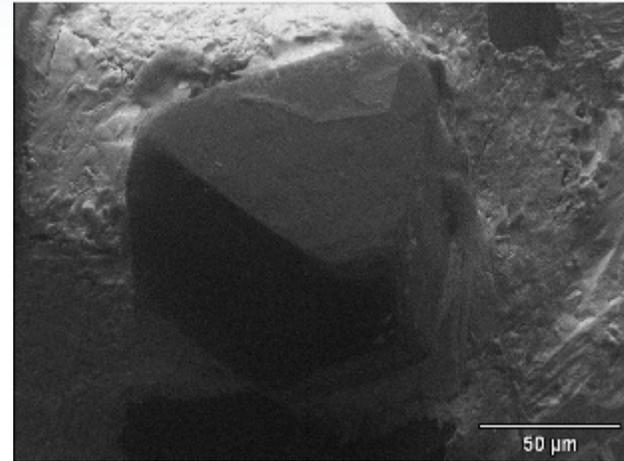
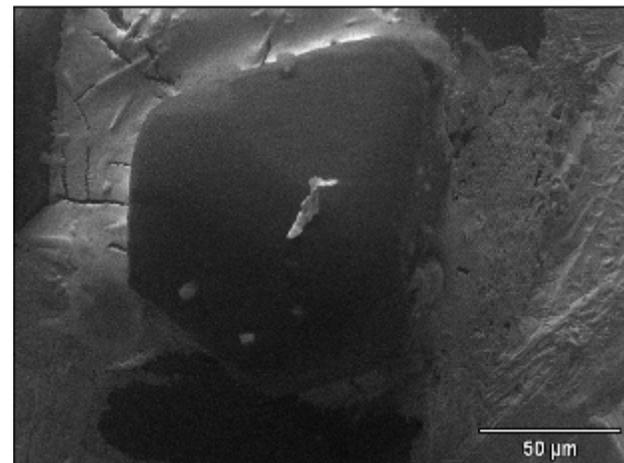
D2 with CMC iCue 600Y75 Slurry at 25 °C

There was micro wear on the cutting edges of aggressive diamonds.
Micro cracks formed on the diamond disc substrate.

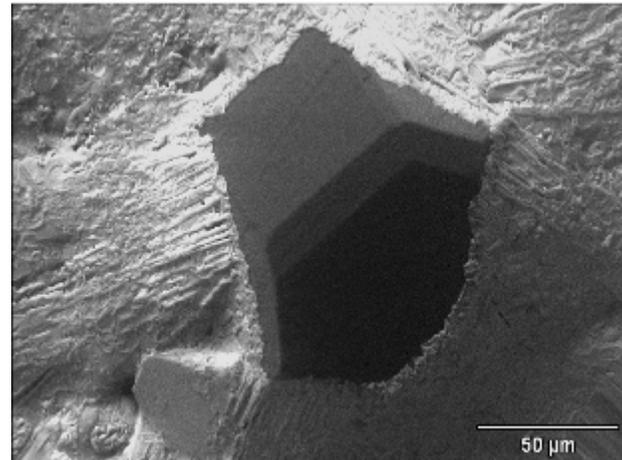
SEM Analysis – Inactive Diamond D2 with CMC iCue 600Y75 Slurry at 25 °C

**There was no appreciable wear on the inactive diamond.
There was appreciable surface corrosion on the diamond disc substrate.**

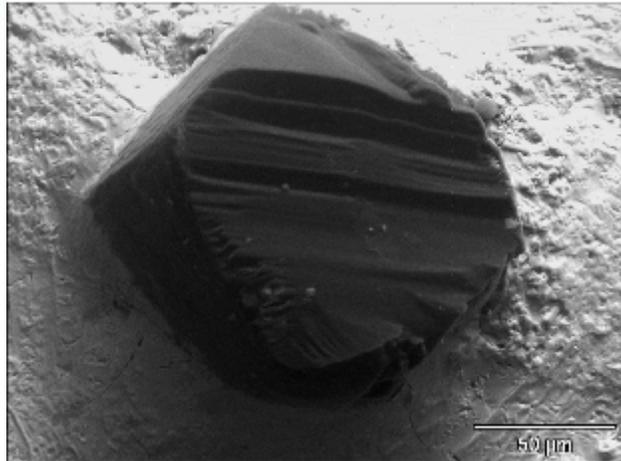
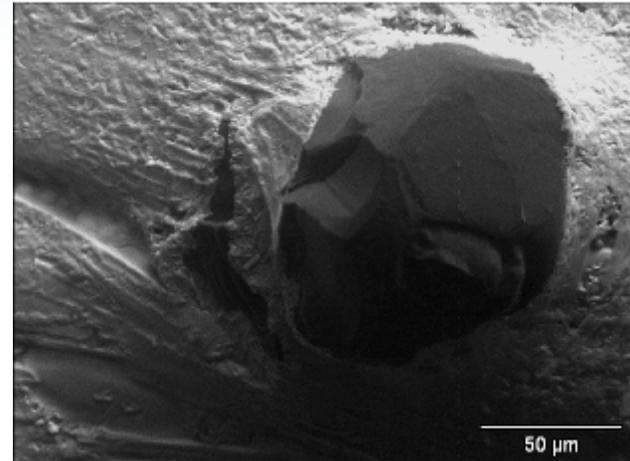
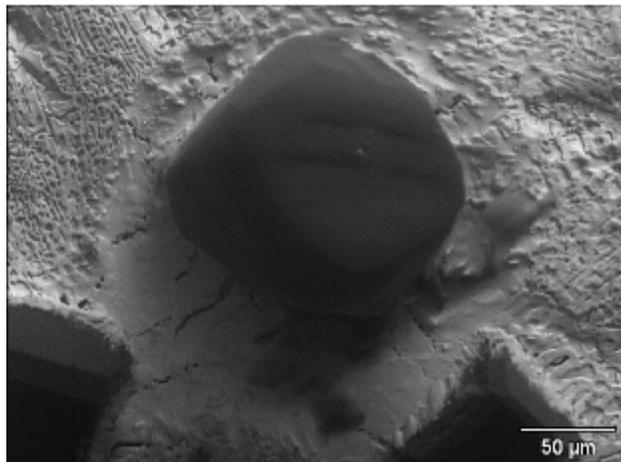
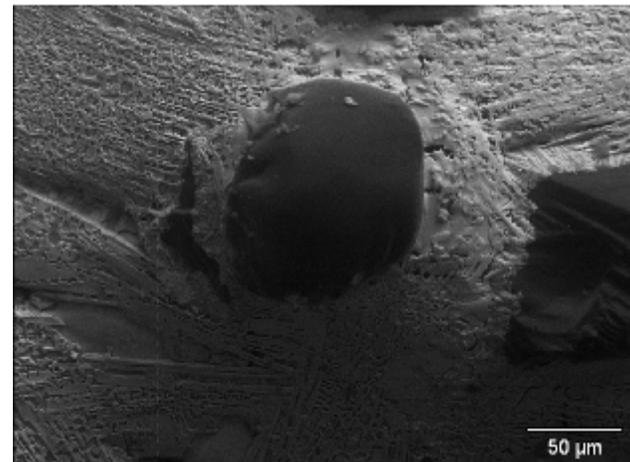
D2 with CMC iCue 600Y75 Slurry at 50 °C

There was micro wear on the cutting edges of aggressive diamonds.
There was apparent surface corrosion on the diamond disc substrate.

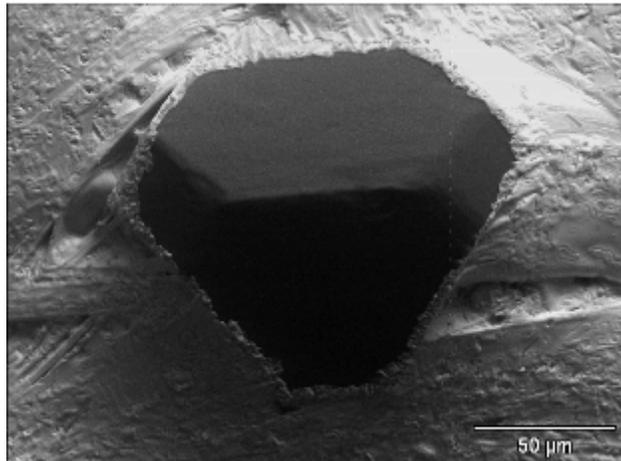
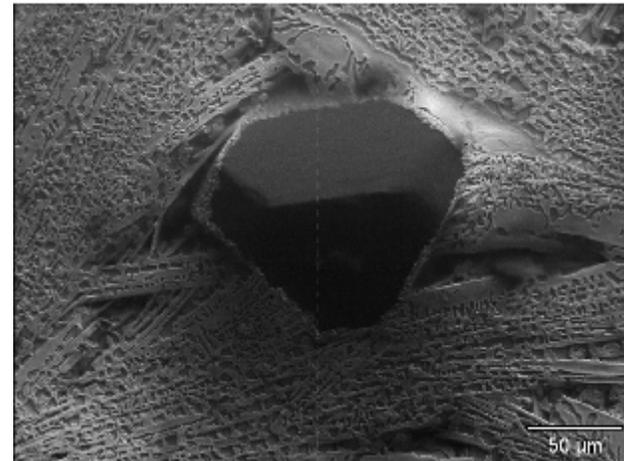
SEM Analysis – Inactive Diamond D2 with CMC iCue 600Y75 Slurry at 50 °C

**There was no appreciable wear on the inactive diamond.
There was apparent surface corrosion on the diamond disc substrate.**

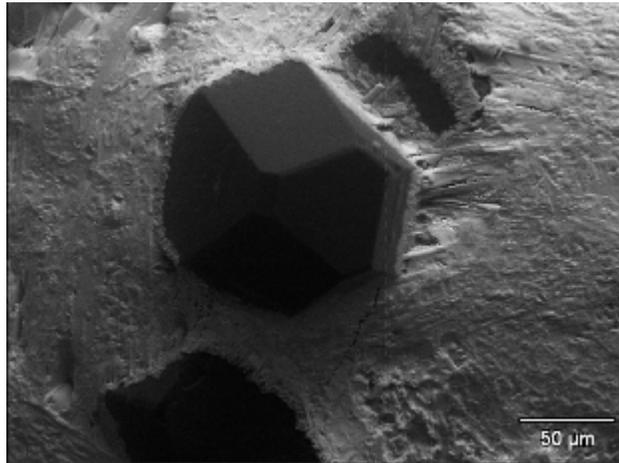
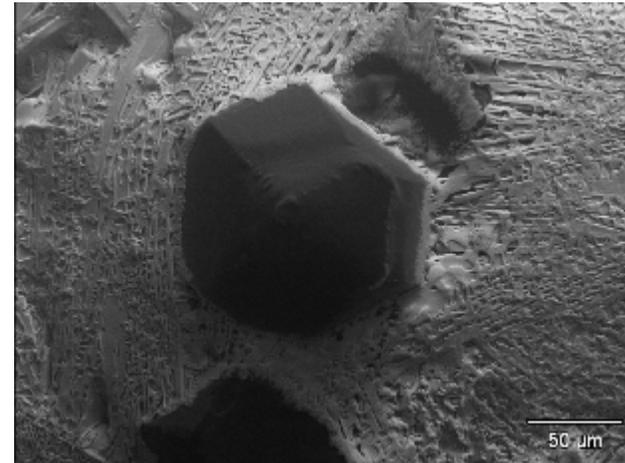
D2 with Fujimi PL-7103 Slurry at 25 °C

**There was micro wear on the cutting edges of aggressive diamond.
There was apparent surface corrosion on the diamond disc substrate.**

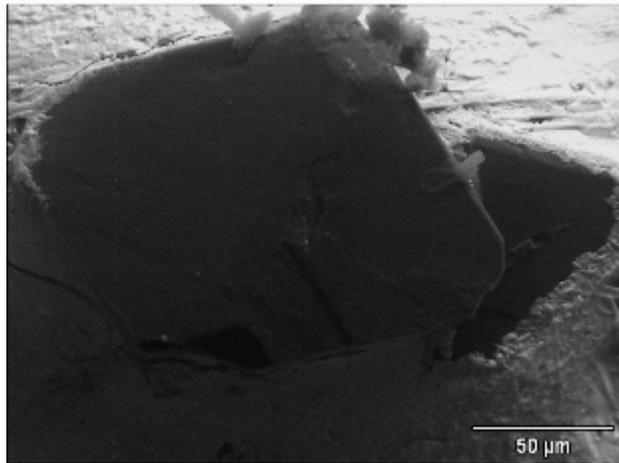
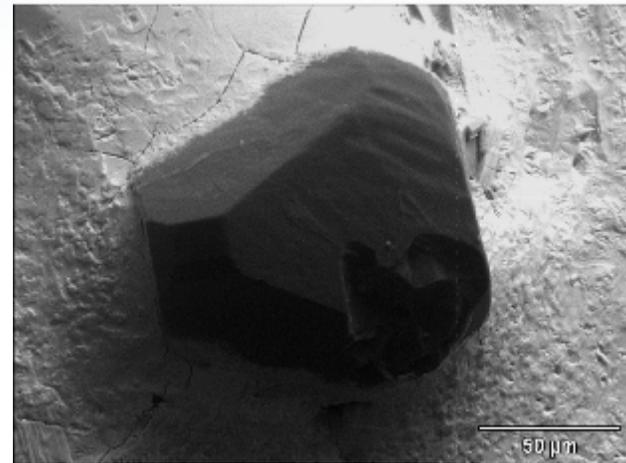
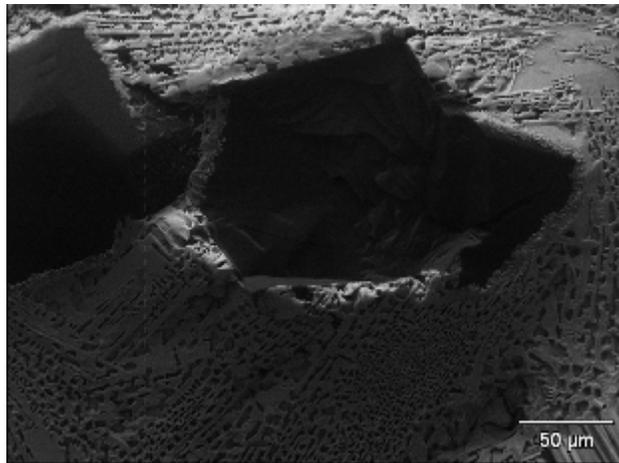
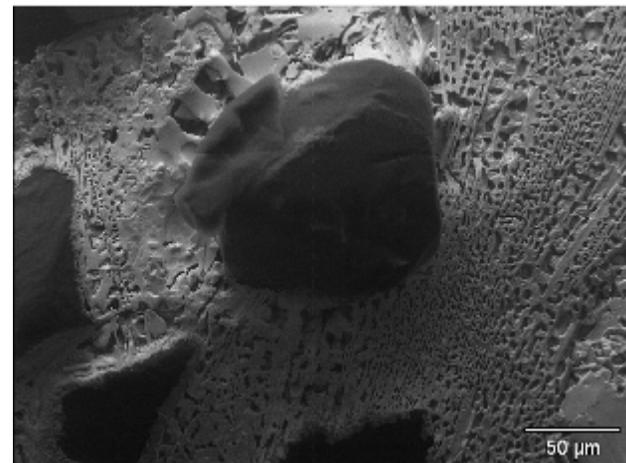
D2 with Fujimi PL-7103 Slurry at 50 °C

**One aggressive diamond broke from the diamond disc substrate.
There was micro wear on the cutting edges of the other aggressive diamond.
There was apparent surface corrosion on the diamond disc substrate.**

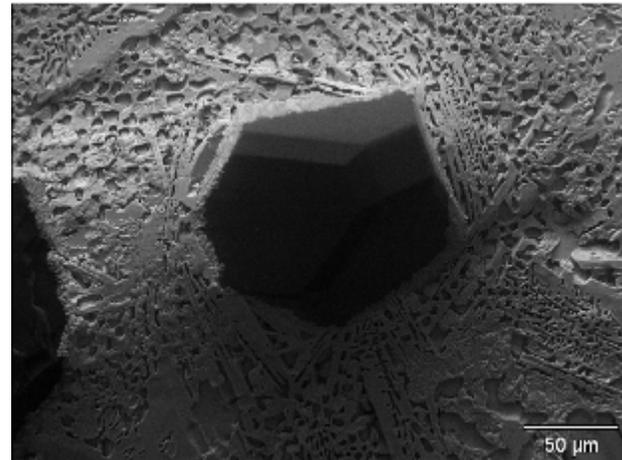
SEM Analysis – Inactive Diamond D2 with Fujimi PL-7103 Slurry at 50 °C

**There was no appreciable wear on the inactive diamond.
There was apparent surface corrosion on the diamond disc substrate.**

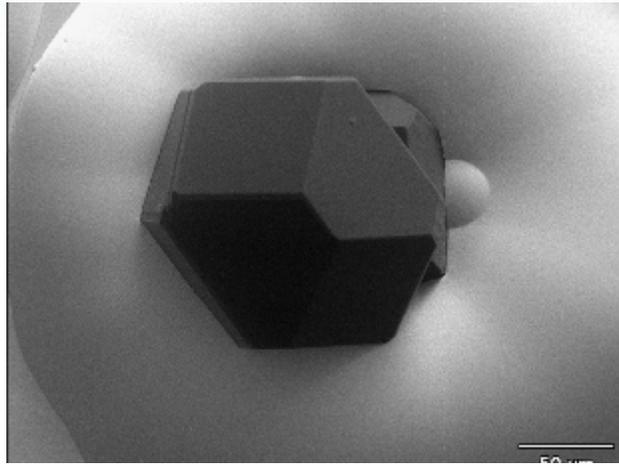
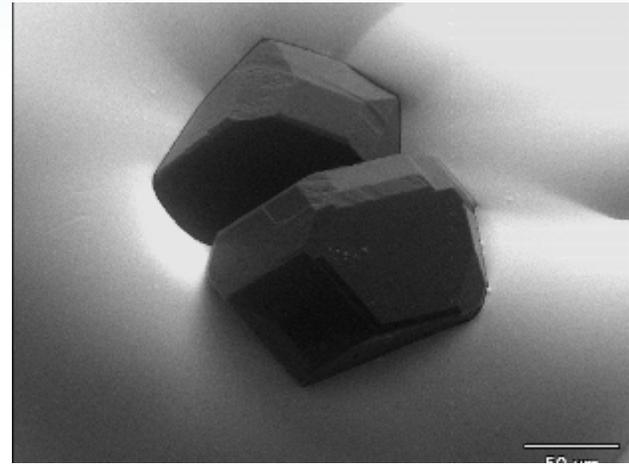
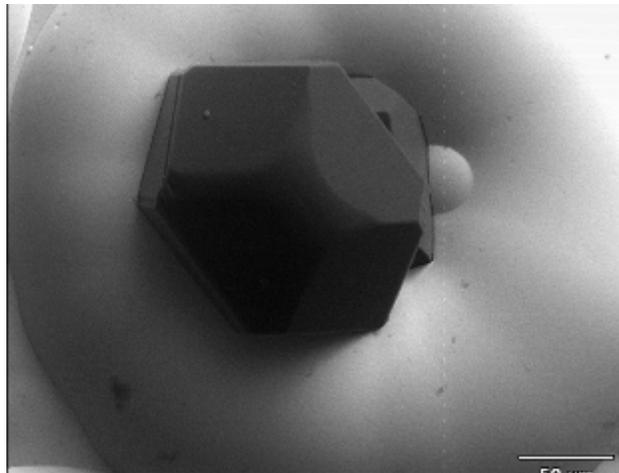
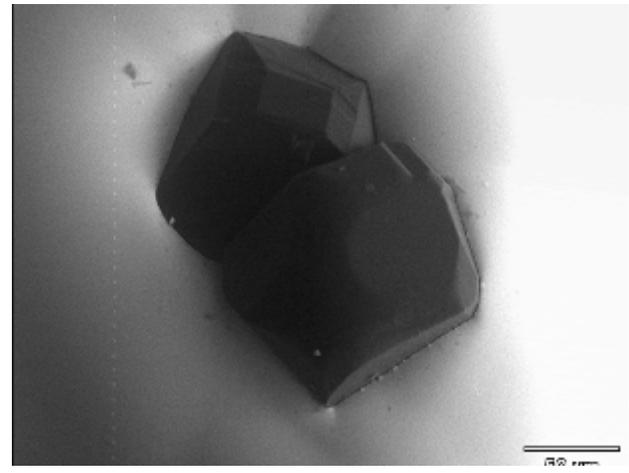
D3 with CMC iCue 600Y75 Slurry at 25 °C

**There was micro wear on the cutting edges of aggressive diamonds.
There was no appreciable wear on the diamond disc substrate.**

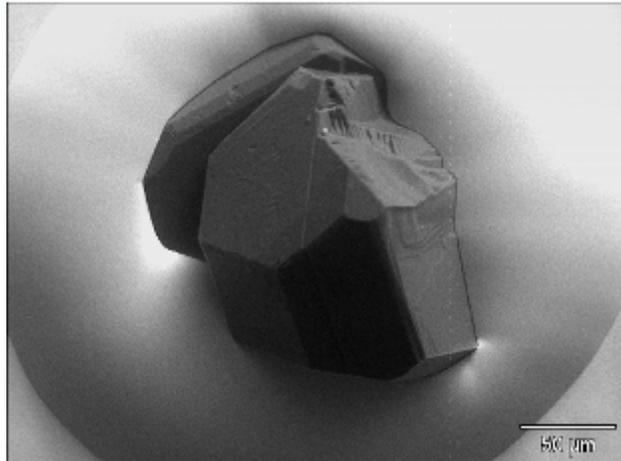
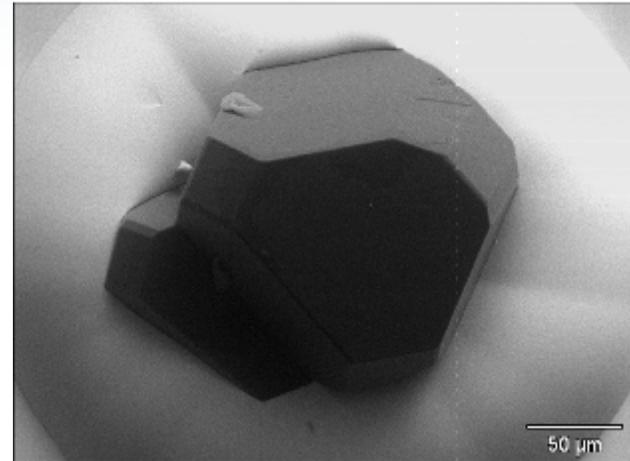
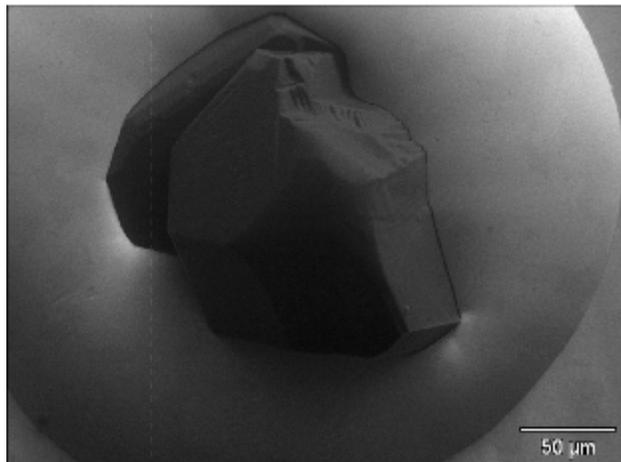
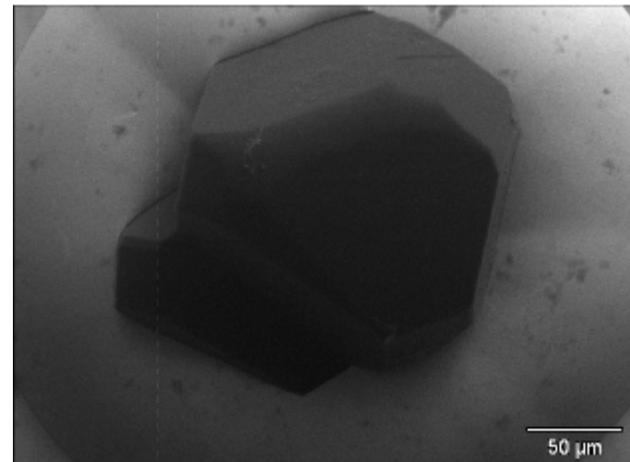
D3 with CMC iCue 600Y75 Slurry at 50 °C

**There was micro wear on the cutting edges of aggressive diamonds.
There was no appreciable wear on the diamond disc substrate.**

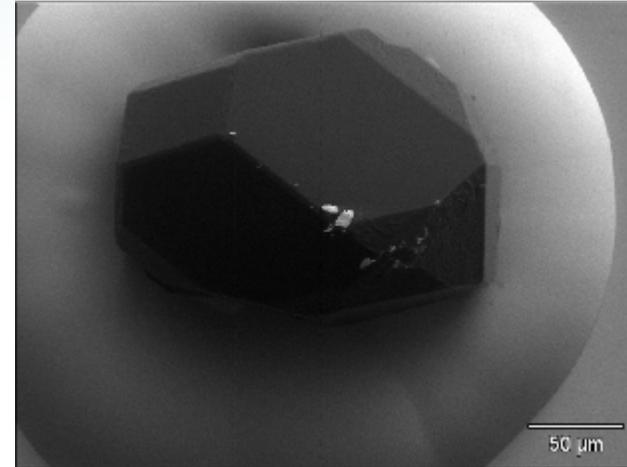
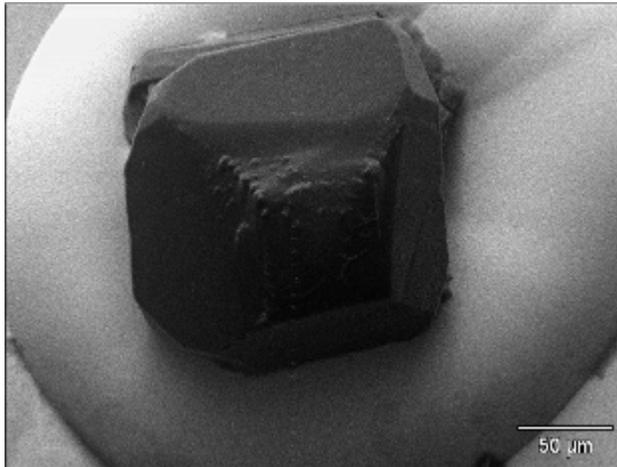
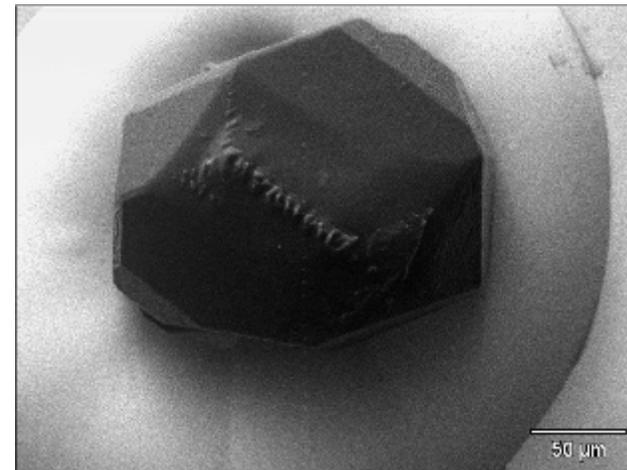
D3 with Fujimi PL-7103 Slurry at 25 °C

**There was micro wear on the cutting edges of aggressive diamonds.
There was no appreciable wear on the diamond disc substrate.**
