Analyses of Diamond Disc Substrate Wear and Diamond Micro-Wear in Copper Chemical Mechanical Planarization Process

**Y. Zhuang ^{1,2}, A. Meled ¹, X. Wei ¹, J. Cheng ¹, Y. Sampurno ¹,
L. Borucki ², A. Philipossian ^{1,2}, M. Moinpour ³, D. Hooper ³**

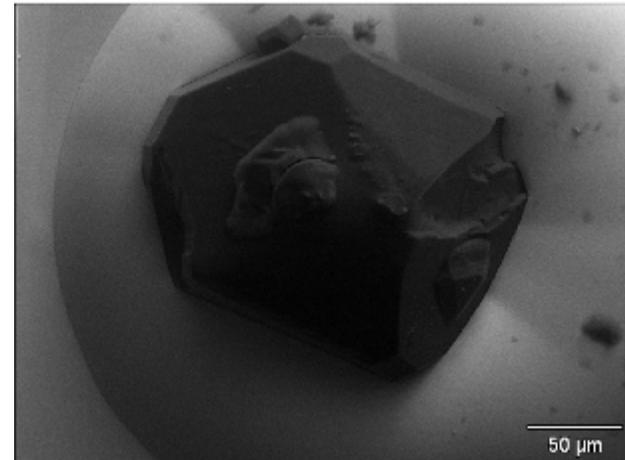
D3 with Fujimi PL-7103 Slurry at 50 °C

There was micro wear on the cutting edges of aggressive diamond.
There was no appreciable wear on the diamond disc substrate.
